**Court Farm, Stoke Road
Westbury-sub-Mendip, Somerset**

Heritage Assessment

CA Project: AN0522

CA Report: AN0522_1

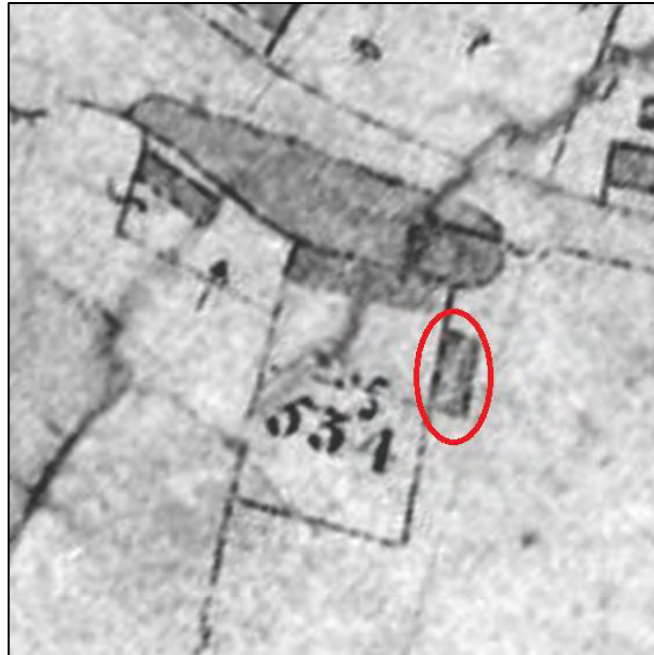
Fig.9 Tithe map buildings detail (granary circled)

5.4. The available mapping thus evidences that the earliest building on the farmstead is the granary, extant by 1838, with the other ranges being constructed in the mid-19th century between 1838 and 1886. Fig.7 from 1971 illustrates that the farmstead expanded in the 20th century with the construction of a number of larger Dutch barn style buildings directly south of the historic farmstead. These would have supported the expansion and functioning of the farmstead as a modern farm.

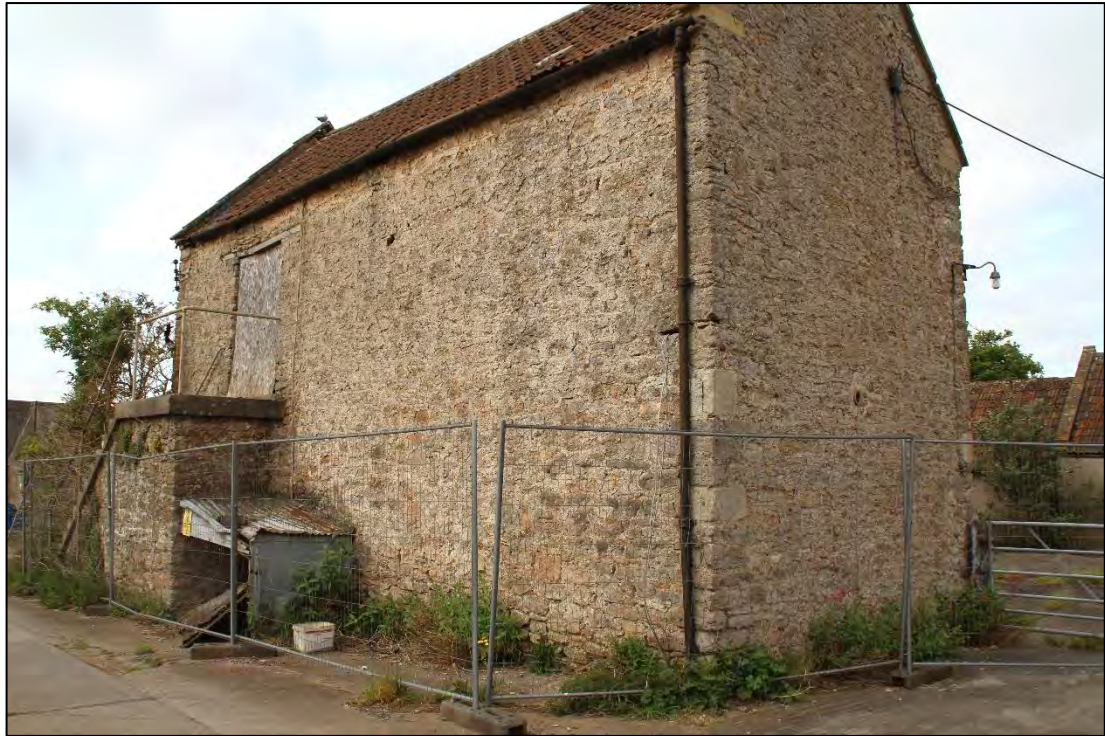
Photo 6 **The granary viewed from the north looking south-west**

- 5.12. The granary is present on the 1838 Tithe Map and thus is an 18th or early 19th century building (Photo 6). It is the only two storey farm building, and is constructed of local rubble limestone under a red clay pantile pitched roof with capped stone gable ridges. It is rectangular in shape and features stone steps on its eastern side, leading up to the first-floor doorway with timber lintel. Due to its condition it was not safe to enter the first-floor area, so this has not been inspected.

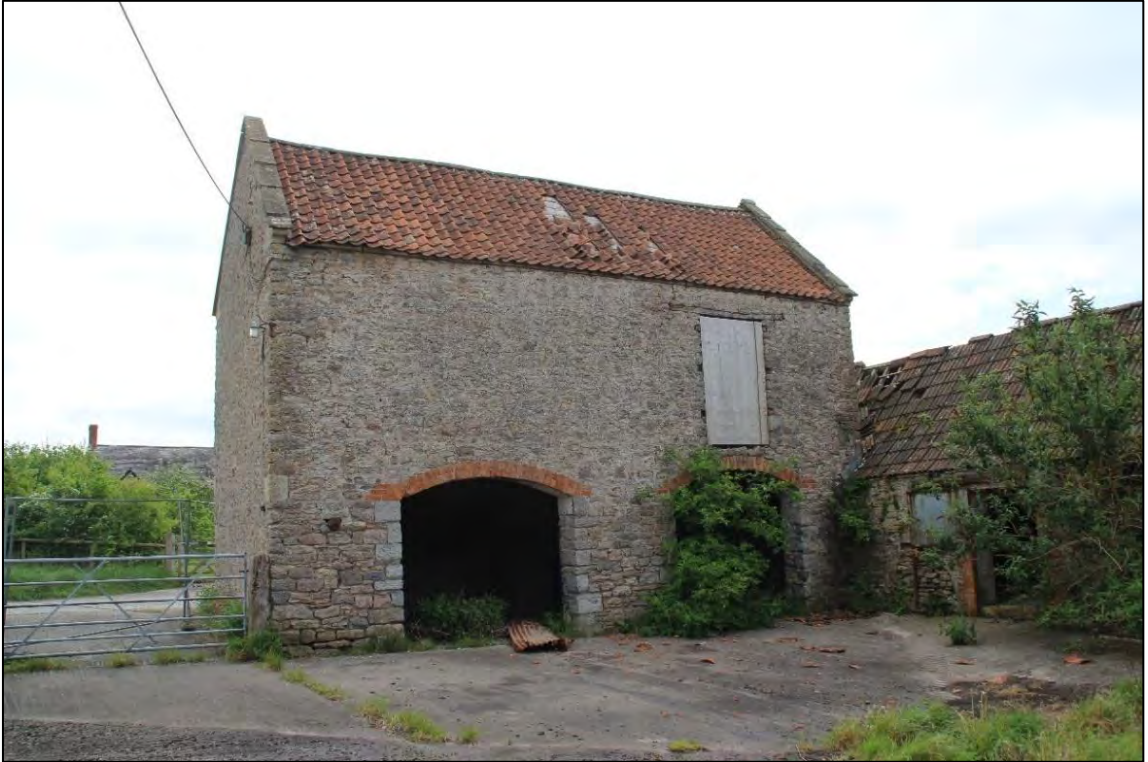
Photo 7 **The granary viewed from the west looking east**

- 5.13. The western, courtyard facing elevation features two arched openings which indicate that this level was used as a cart shed. The arches are headed and dressed in brick with large, coursed stone blocks dressing the sides of the openings. A first-floor hoist door is seen above the southern arched opening, this is where the grain/hay stored at this level would have been hoisted into the farm courtyard for feed and/or processing.
- 5.14. Internally, the cart shed has a rough rubblestone wall finish, and a large timber lintel provides structural support to the south gable, which is also appended to Building A. The structure of the upper floor can be seen from the ground floor; it is formed of thick joists supporting timber boards, with criss-cross bracing to some of the joists which is often seen in farm building construction, as seen in Photo 9.

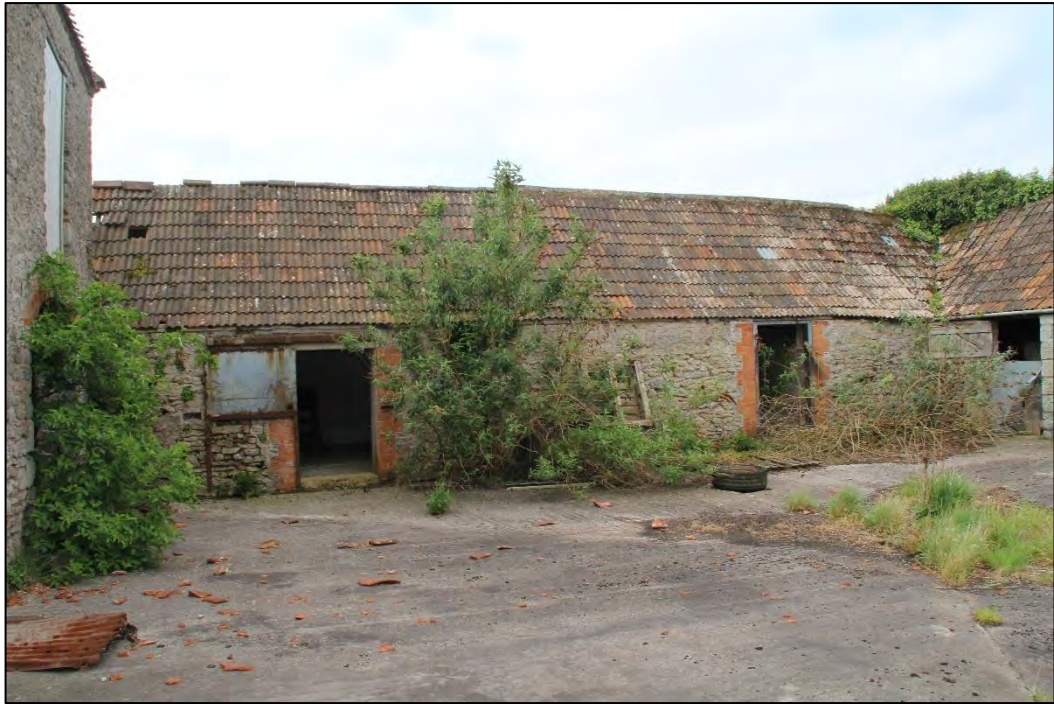
Photo 10 **Building A viewed from the north looking south**

- 5.15. Building A is a one storey linear range running east-west as best seen in Fig.11. It is appended to the granary on its southern side and as with the other traditional buildings of the farmstead it is constructed of semi-coursed rubblestone with brick dressings and a clay pantile roof of ridged construction. At the eastern extent the roof forms an extended hipped corner to return northwards and abut the granary. It is first seen in the 1st Edition OS map of 1886 and was likely built in the 1850's or 60's. The map illustrates that it was open fronted on its southern side (indicated by dashed parts) indicating its use as an animal shelter. As seen in Photo 10, it forms the southern enclosure of the farm courtyard. On its northern elevation, it features two wide door openings dressed with brick. The eastern opening of the northern elevation has a concrete lintel and appears to have been altered to accommodate a secure metal door.

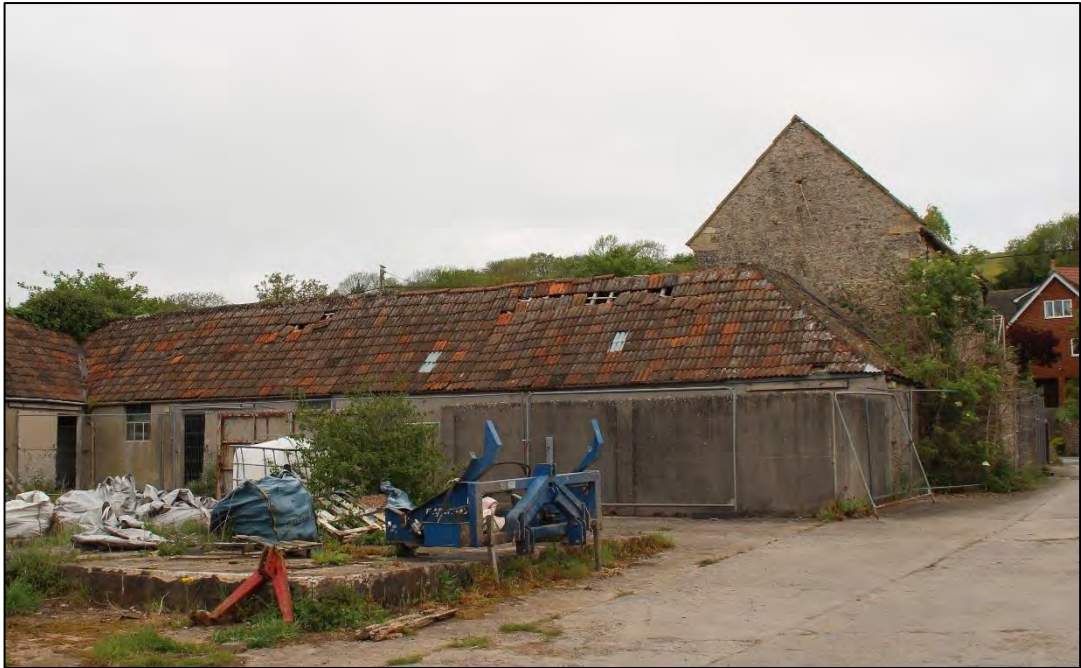
Photo 11 **The southern elevation of Building A**

- 5.16. The southern elevation is seen in Photo 11. It has been rendered, likely in the second half of the 20th century (it being open fronted in 1886), and a concrete block open yard has been appended to it on its eastern half. This yard was not accessible but appeared to be some sort of animal pen. The western half of this elevation is shown in Photo 12 and illustrates how the building has been rendered and altered with modern metal door openings. Two metal windows with top hopper openings are also present, and likely to be later additions.

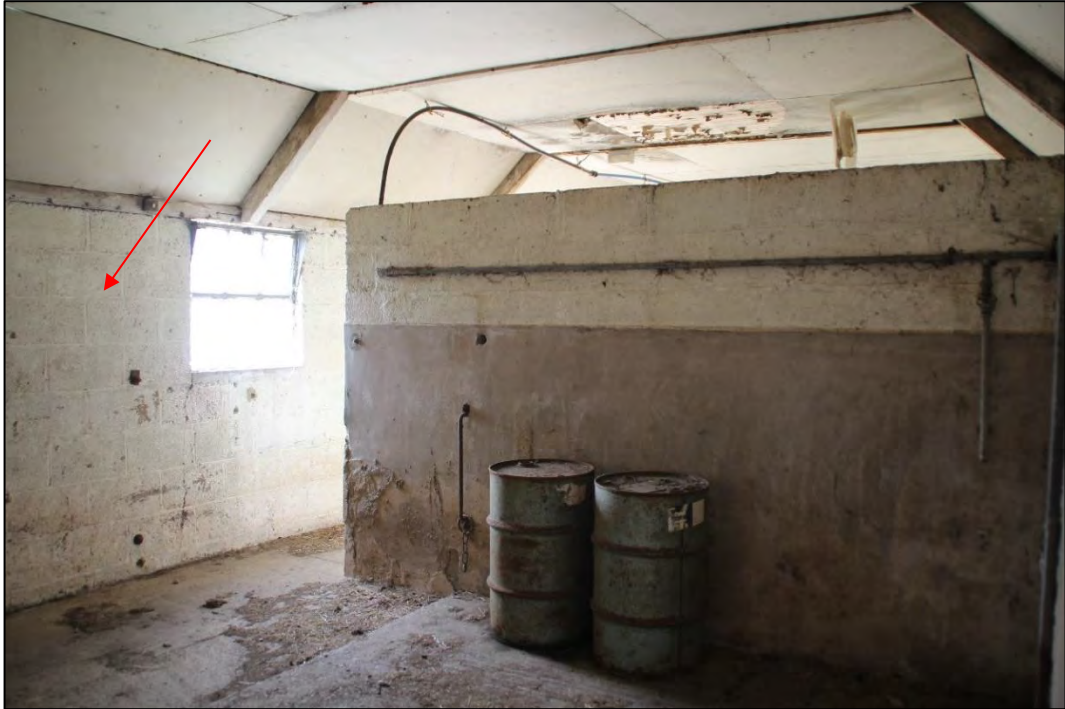
Photo 13 The interior of Building A, with concrete block southern wall arrowed

5.17. For safety reasons this building was only examined from doorways. Internally it has been modernised with the construction of large stalls constructed of concrete blockwork as seen in Photo 13. This also evidences how the southern elevation has been rebuilt in concrete blockwork (as arrowed). As also can be seen in Photo 13, a

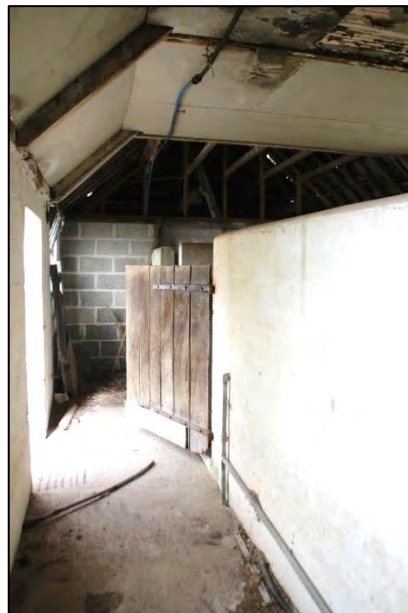
Photo 14 Interior of Building A looking west

- 5.18. A view taken looking west along the building illustrates how the tall animal stalls dominate the space and how a half height concrete block wall has been constructed at the junction with Building C, though the roof structure continues to be visible.

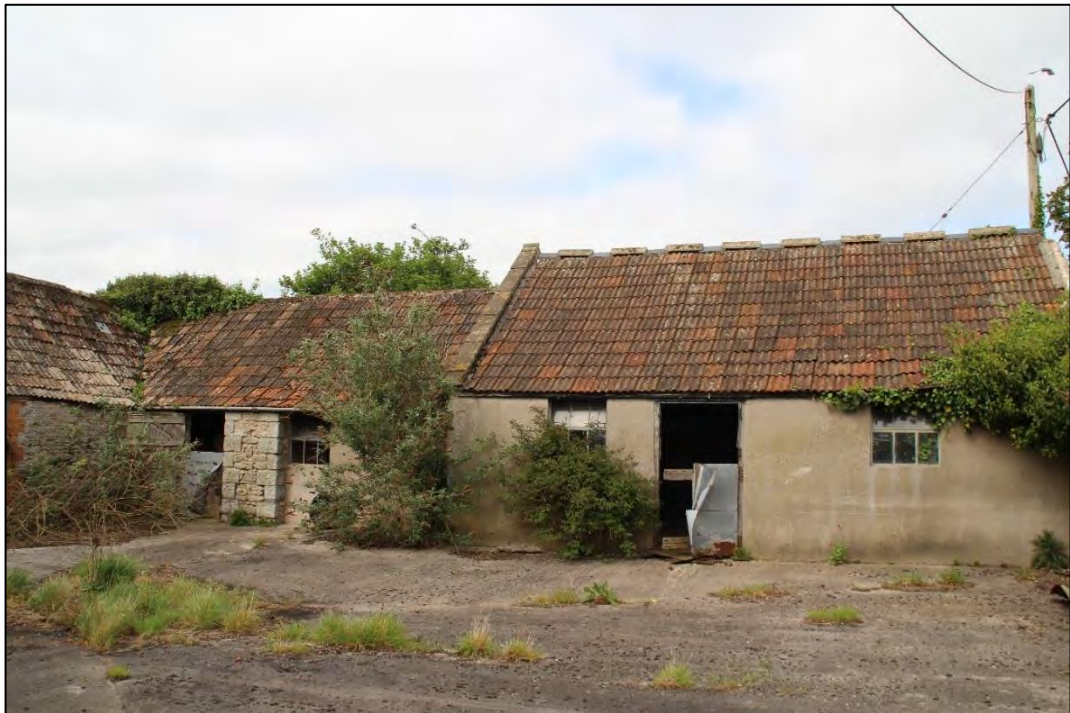
Photo 15 **Building B seen from the east looking west**

- 5.19. Building B forms part of the west side of the courtyard enclosure as seen in Photo 15. As can be seen, it connects with Building C, but is distinct in form and scale. It has been rendered on its eastern face, and internal inspection confirmed that the construction is now cement blockwork on this elevation. Two metal hopper windows have been inserted here. A centrally placed stable accesses the internal space. The roof is formed of clay tiles with an interesting ridge line of what appears to be paired stone and slate ridge pieces. The rear (western) elevation is formed of rubblestone as seen in Photo 16, this likely being the original appearance of the eastern elevation.

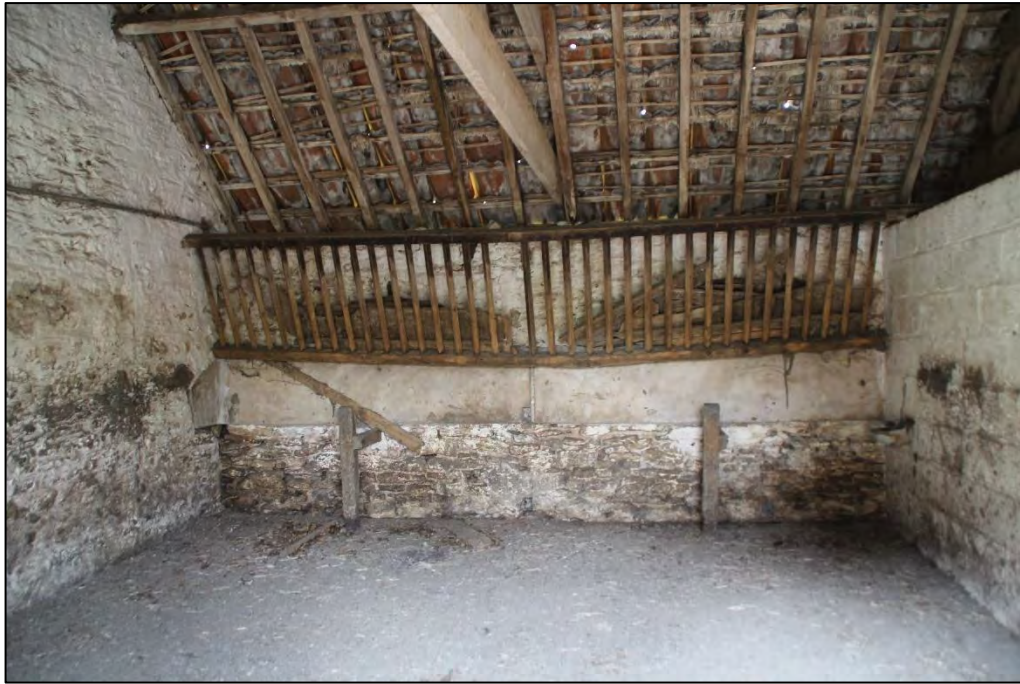
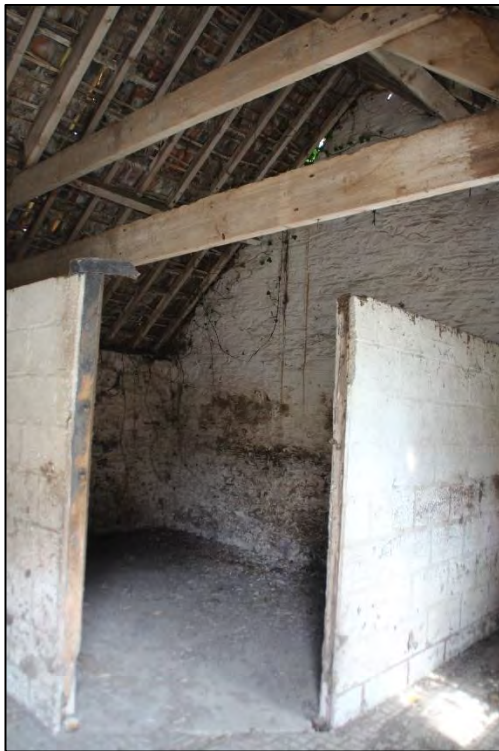
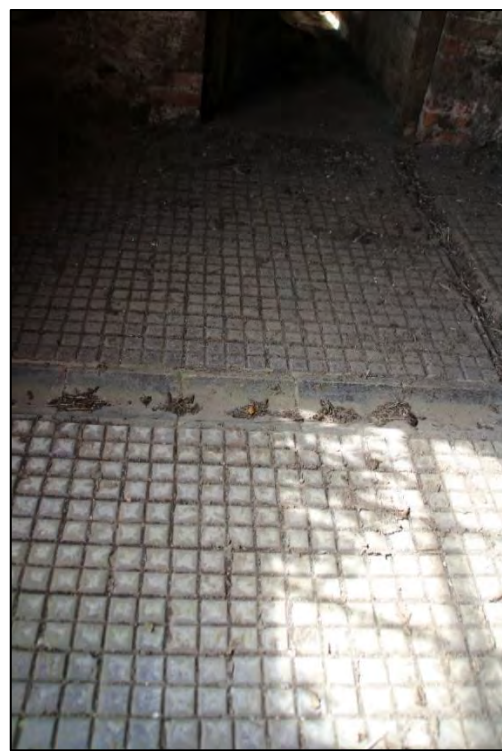
- 5.20. Internally the building is of largely traditional construction with what appears to be an original roof (evidenced by the patina of rafters and battens), though it may be that the building was thatched judging by the remnants of straw that are adhering to the roof side of the battens. This would also explain the interesting new ridge formation. A concrete blockwork stable or stall has been created in the north-west corner as seen in Photo 18, whilst a traditional hay rack is appended to the western wall, albeit some cement layering has been added to the wall beneath, possibly to stabilise the rack. The floor has been partially laid to 20th century square tile cobbles as seen in Photo 19. At the southern end, the building is interlinked with building C via a brick dressed doorway.

Photo 17 View of the hay rack in Building B

Photo 18 (left) modern stall in Building B

Photo 19 (right) 20th century floor 'cobbles' in Building B

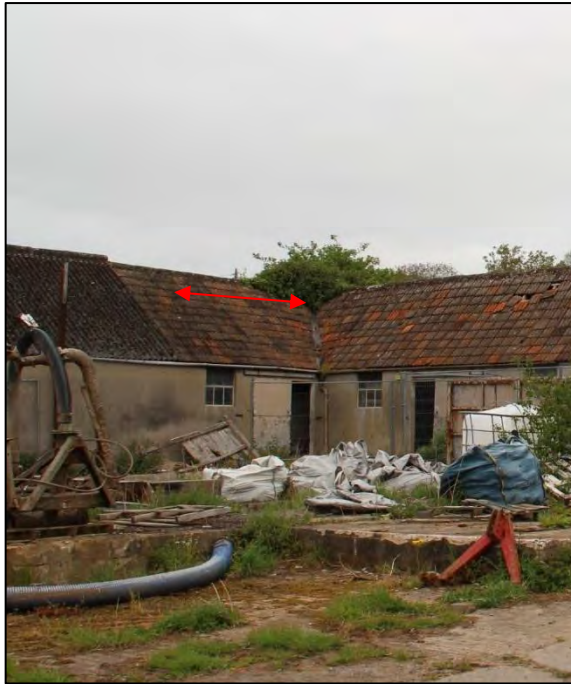
Photo 21 View of Building C (arrowed)

- 5.21. Building C forms the middle range of the traditional linear range that extends north-south on the Site. It connects at right angles with Building A and is internally connected here also. It is a simple one storey range with pitched clay tile roof. The eastern elevation is seen in Photo 21 and shows a modernised wall with metal hopper window and wide barn style opening with sliding door. The eastern elevation is seen in Photo 22, showing a modern rendered section of wall alongside a retained section of stone work adjacent to a wide stable door. Much of the exterior on the western side was obscured by vegetation but the eastern elevation facing the open modern courtyard is seen in Photo 23; as evident much of the exterior fabric has been removed and concrete blockwork built in its place.

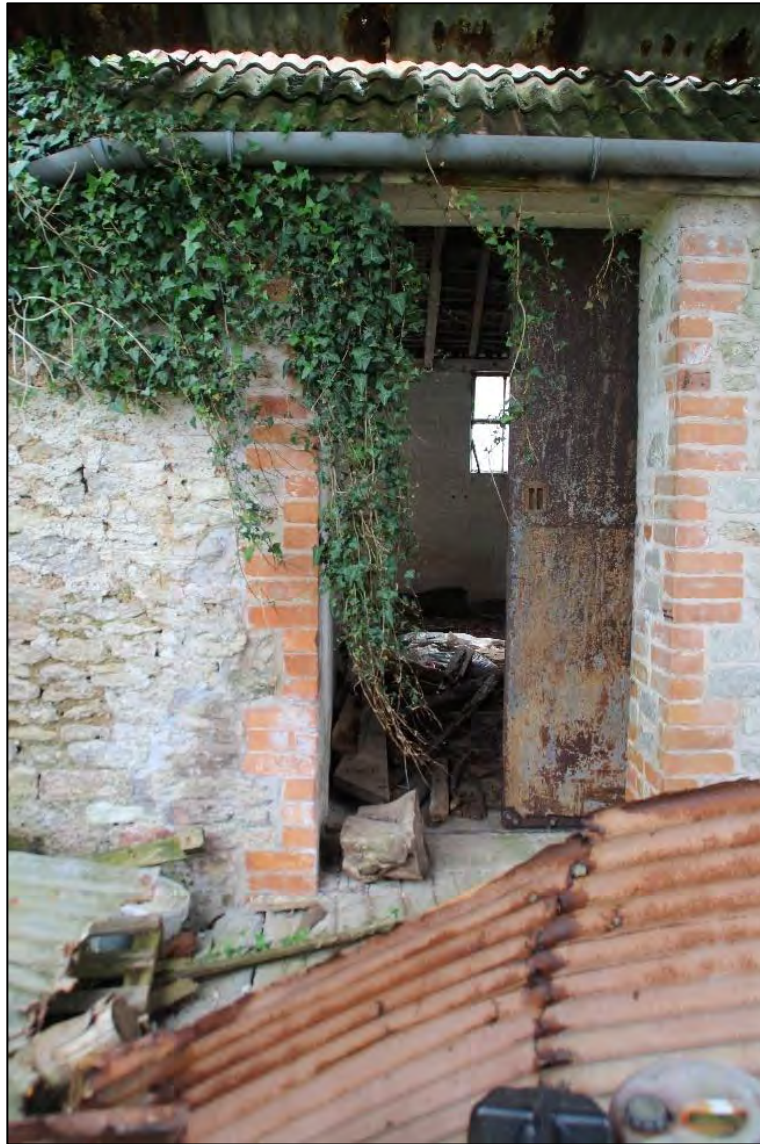
Photo 23 **The western door of Building C**

5.22. The west facing elevation is largely obscured but a brick dressed door opening is present as seen in Photo 23, and the walls of both Building C and D on this elevation are rubblestone.

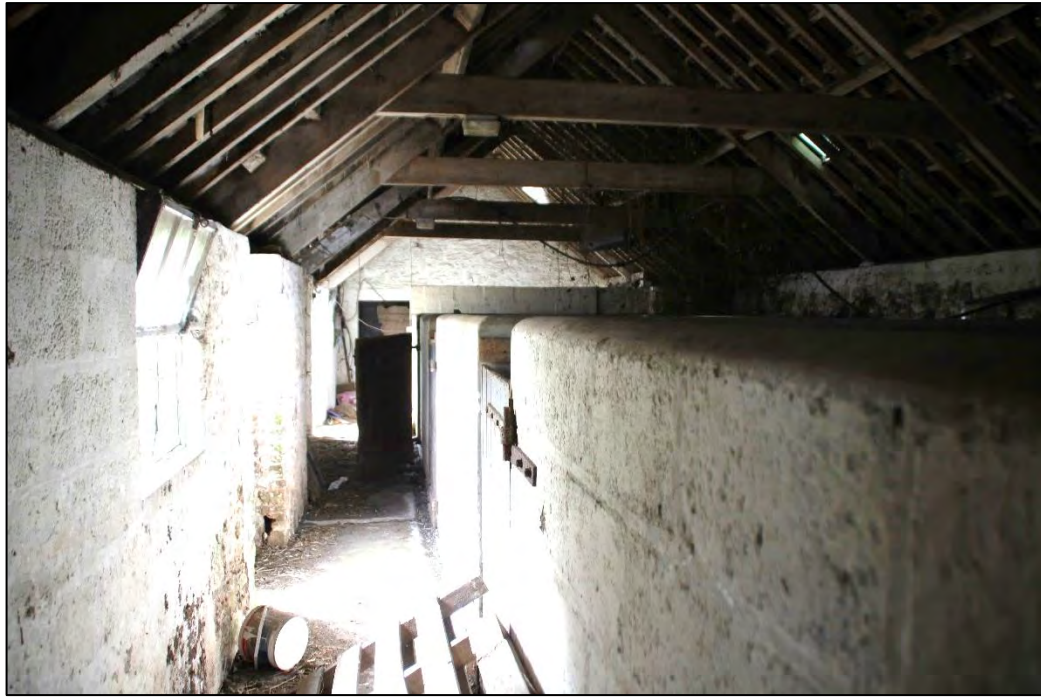
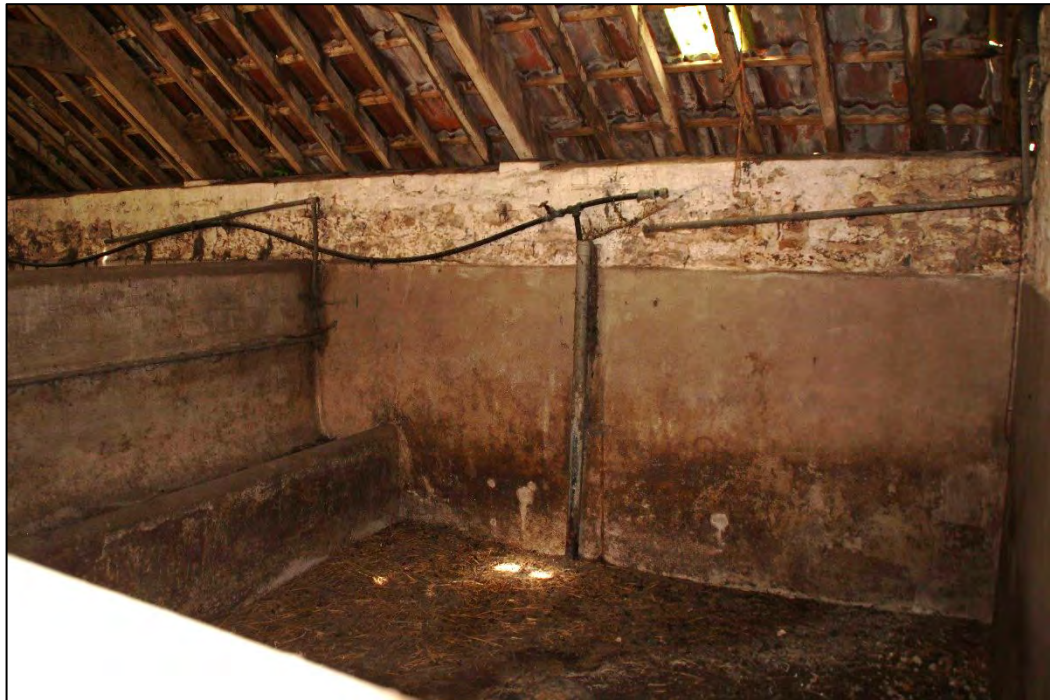
- 5.23. Internally the building is subdivided into stalls as seen in Photo 24, the stalls appear modern due to the use of concrete blockwork. This is corroborated in Photo 25, where cement render is present lining the interior of the stall, likely present for reasons of washing and hygiene. The roof structure is plain truss with collar of potential original machine cut pine construction.

Photo 24 Internal view of Building C looking south

Photo 25 Internal view of stall in Building C

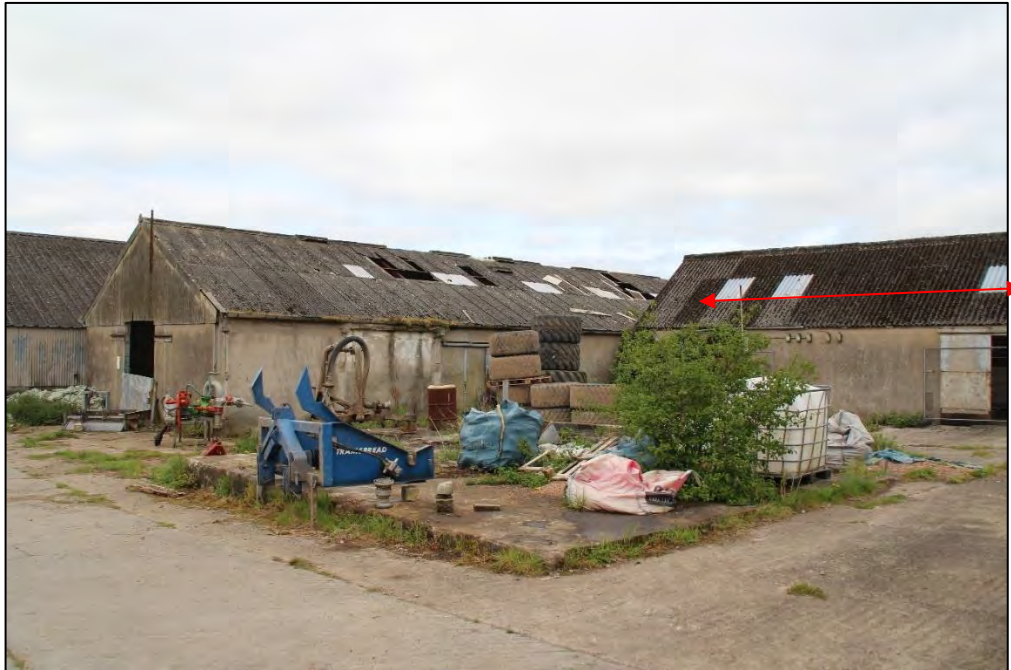
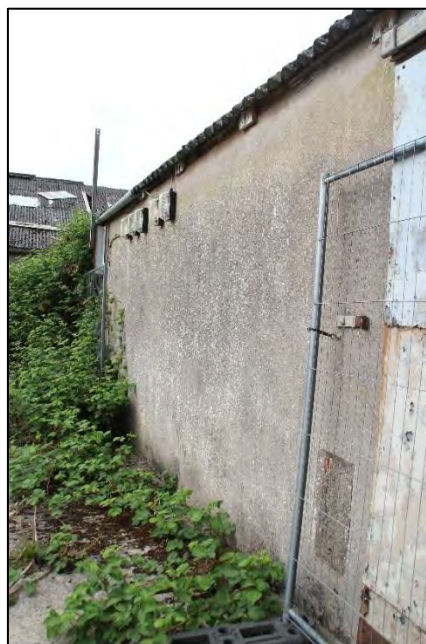
- 5.24. Building D forms the southernmost of the linear ranges oriented north-south. It first appears on mapping in 1886 and is likely contemporary with buildings B and C. In its eastern elevation it has modernised with render and new window openings as seen in Photo 26. The rear western elevation is rubblestone. The roof is also what appears to be corrugated asbestos or similar.

Photo 26 View of Building D from the east (arrowed)

Photo 27 Detail of the eastern wall of Building D

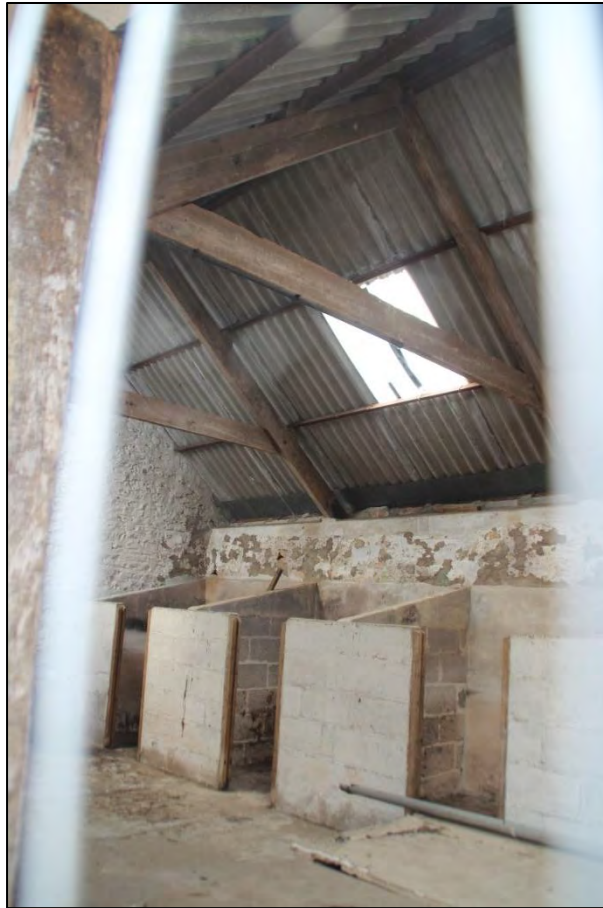
Photo 28 **The interior of Building D**

-
- 5.25. The interior was inaccessible but images were taken from behind the barrier fencing. As can be seen in Photo 28, the interior of the building has been modernised with the concrete block work to create stalls. A new roof structure is also evident though the main trusses may have been re-used.

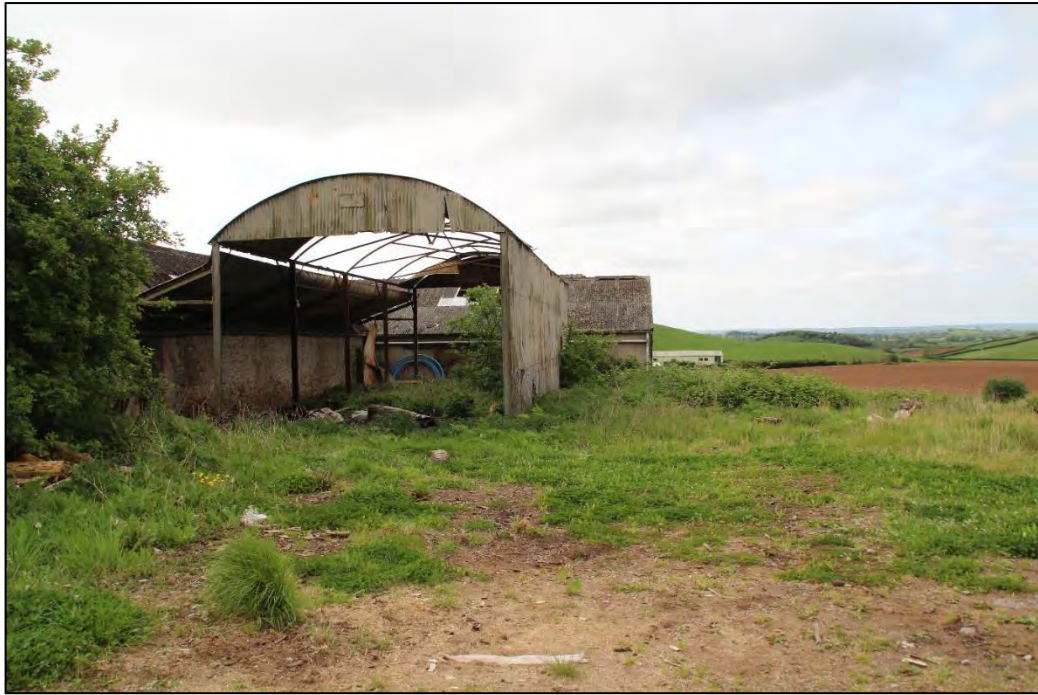
Photo 29 Modern barn E appended to Buildings C and D

- 5.26. Building E is an open Dutch barn which has been appended to Buildings C and B, as best illustrated in Photo 29. Buildings F to I are all 20th century barns of modern construction (both enclosed and open sided) and are illustrated in Photos 30 to 32. These buildings have not been surveyed due to their modern construction.

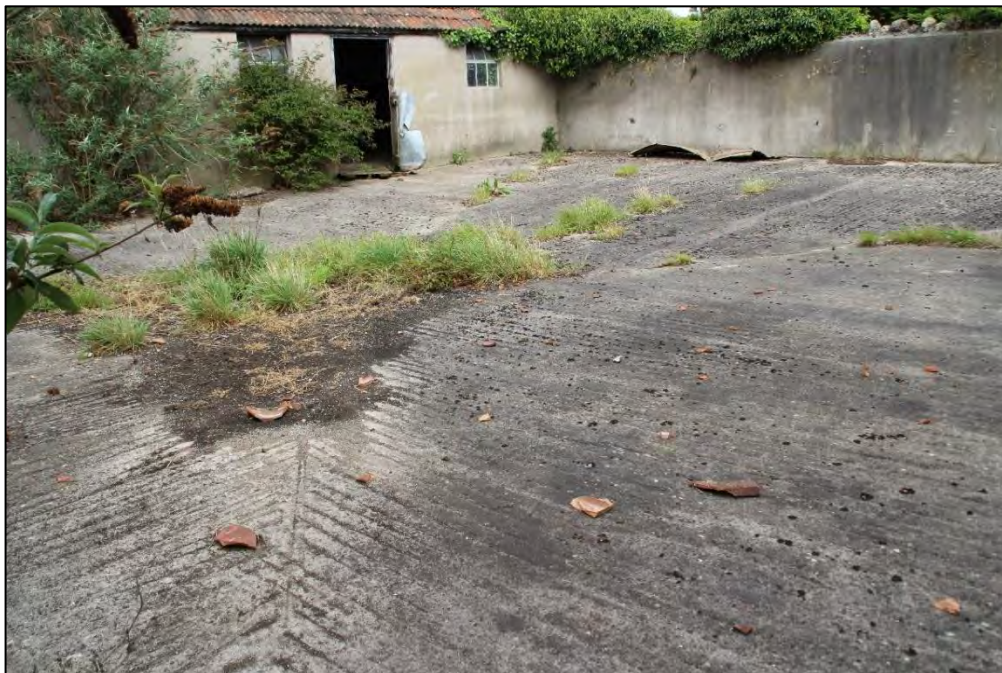
Photo 34 **The courtyard cement ground surface**

layer of cement (likely for cleaning and hygiene reasons) and the courtyard surface is also cement, lightly sloped for drainage as seen in Photo 34.

6.10. Heritage benefits to assist in the planning balance would flow from works which looked to repair fabric in poor condition, to reinstate or uncover historic fabric and features such as walling (removing cement render for example) and to reinstate a more traditional character to surfaces such as the courtyard and courtyard stone walling.
